**FINAL PROJECT REPORT**

**RD/RA OVERSIGHT  
PROJECT ASSISTANCE**

**HOWE VALLEY LANDFILL SITE  
HOWE VALLEY, HARDIN COUNTY, KENTUCKY**

**Work Assignment No. 17-4XN8**

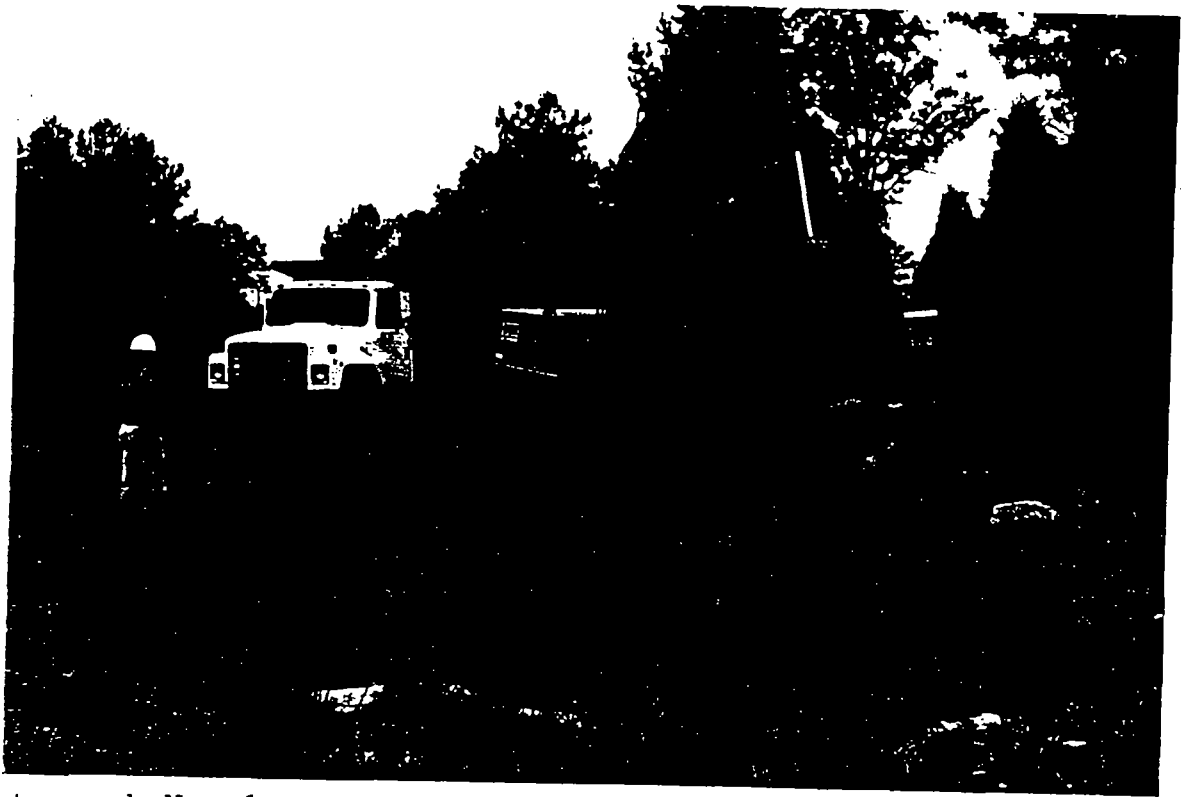
Photograph No. 1                      Date: September 2, 1992  
Location: Howe Valley Landfill, Hardin County, Kentucky  
Description: View of Area 7D as excavation activities commence.

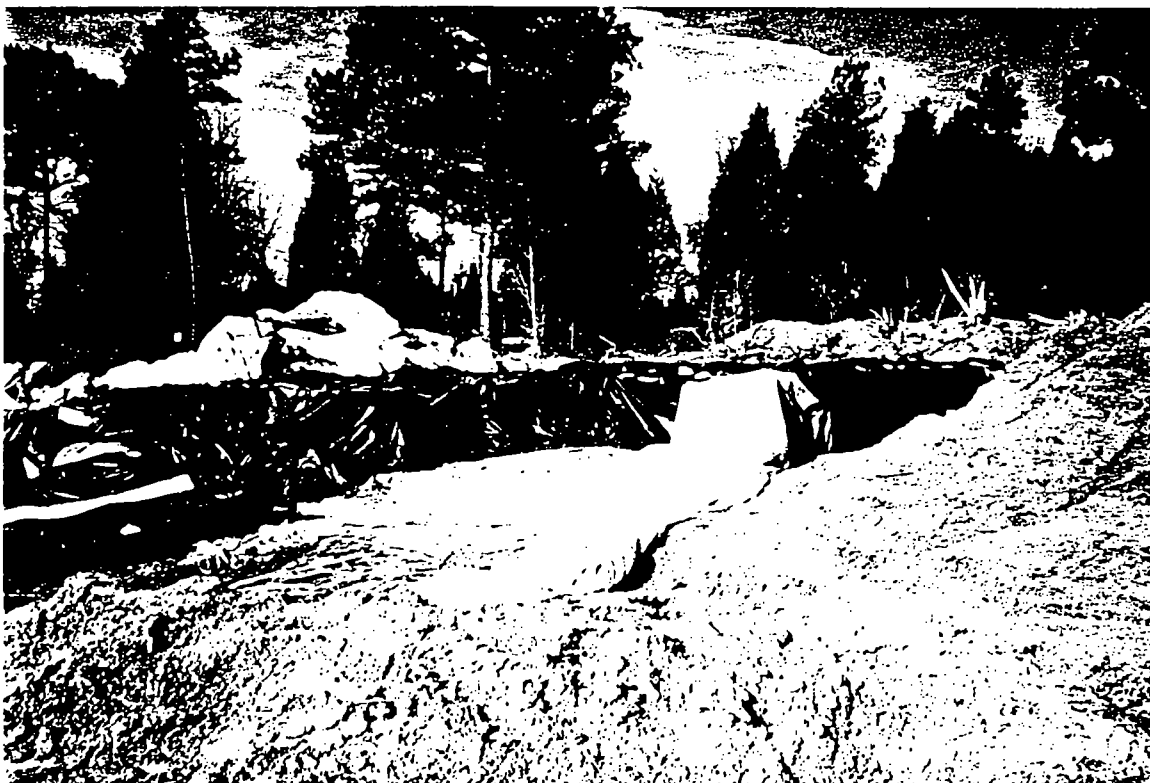
**Photograph No. 2**

**Description:** Recovered drums remain overpacked and covered awaiting final disposal arrangements.

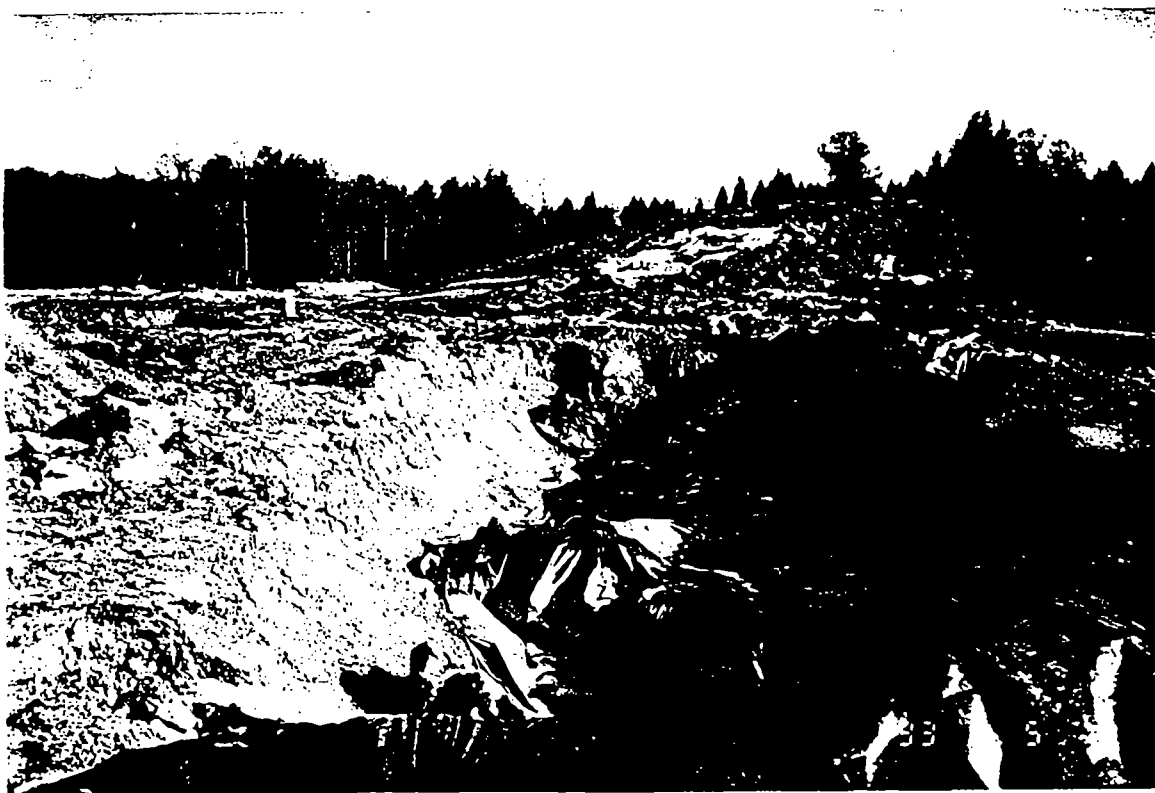
**Photograph No. 4**

While on-site, WESTON's Ralph McKeen observed the entire site to document the status of all site activities. The two drum excavation areas remain open but lined with 6 mil visqueen (Photograph No. 4). The excavated drums remain staged and covered with visqueen (Photograph No. 2). Three aeration areas are now prepared for continued roto-tilling operations. Organic contaminated soils have been stockpiled adjacent to the aeration areas.

**Description:** One of the two drum removal location areas.

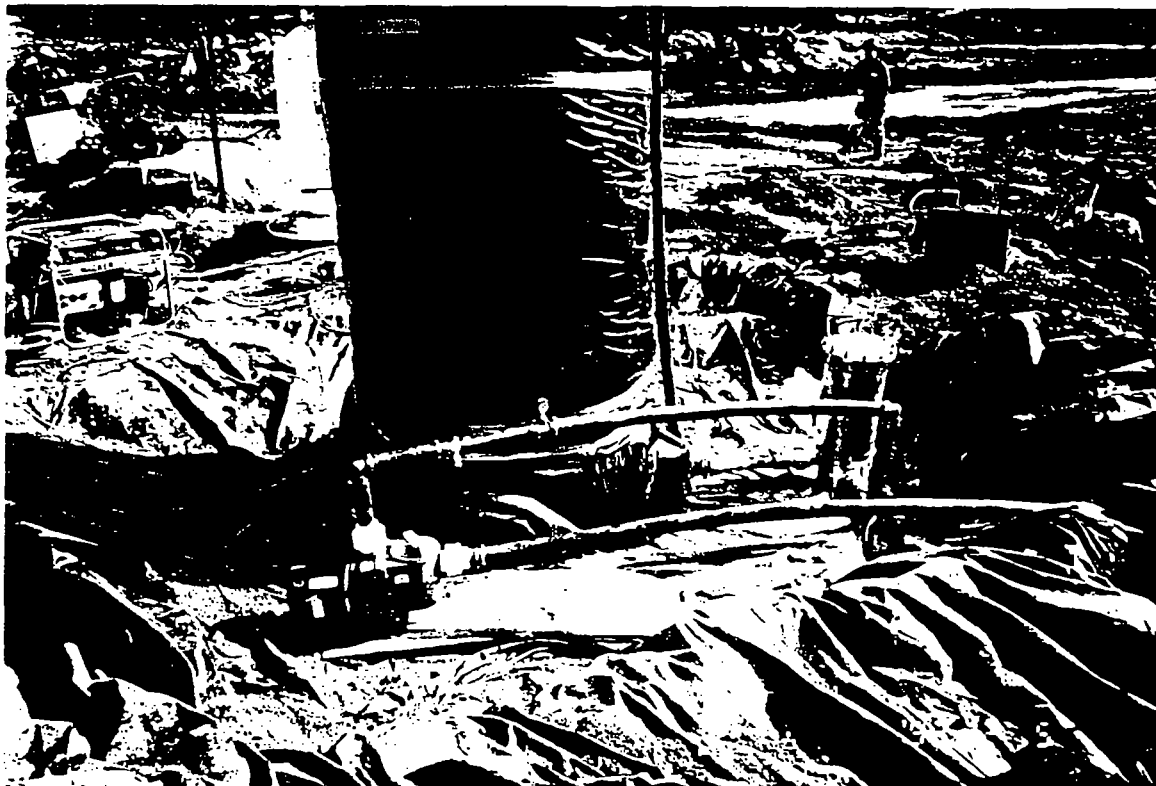
**Photograph No. 5**

**Description:** View of the granular activated carbon (GAC) unit, pump and prefilter. The GAC unit has been insulated and wrapped to prevent freezing.

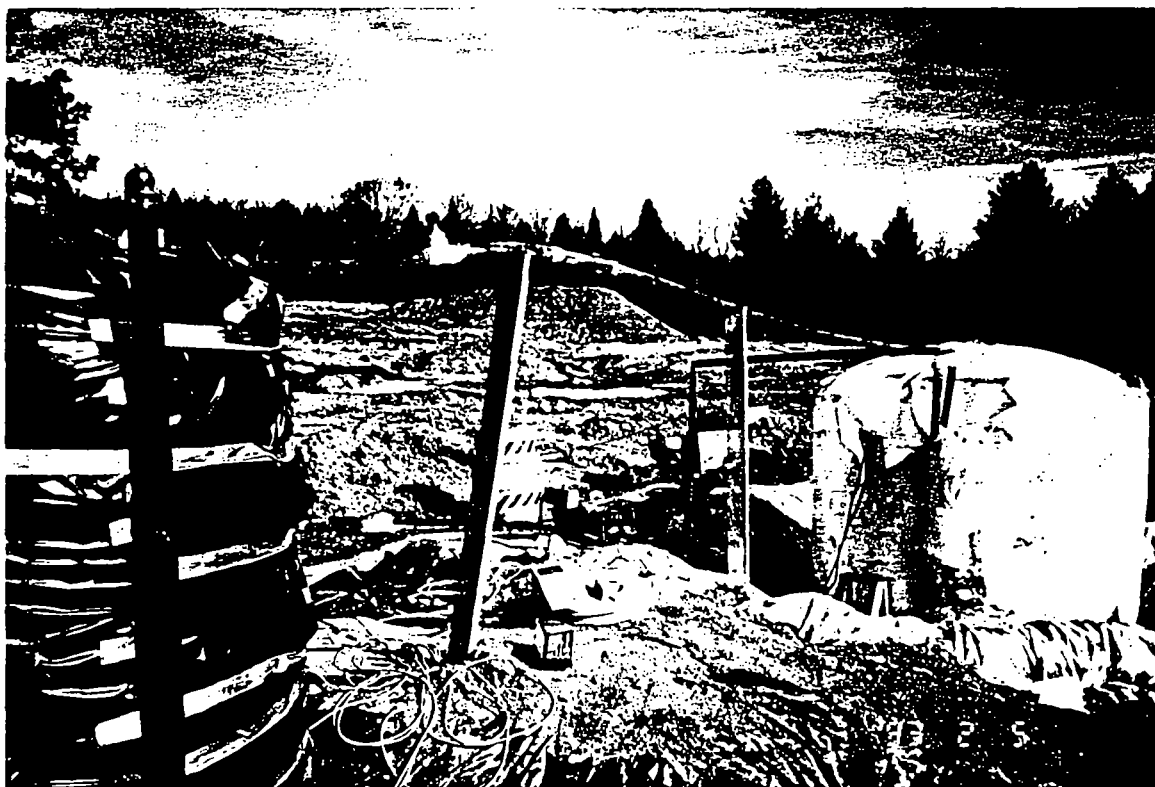
**Photograph No. 6**

**Description:** Effluent line from GAC unit discharges into the 2500 gallon poly tank and subsequently pumped to the collection pond.

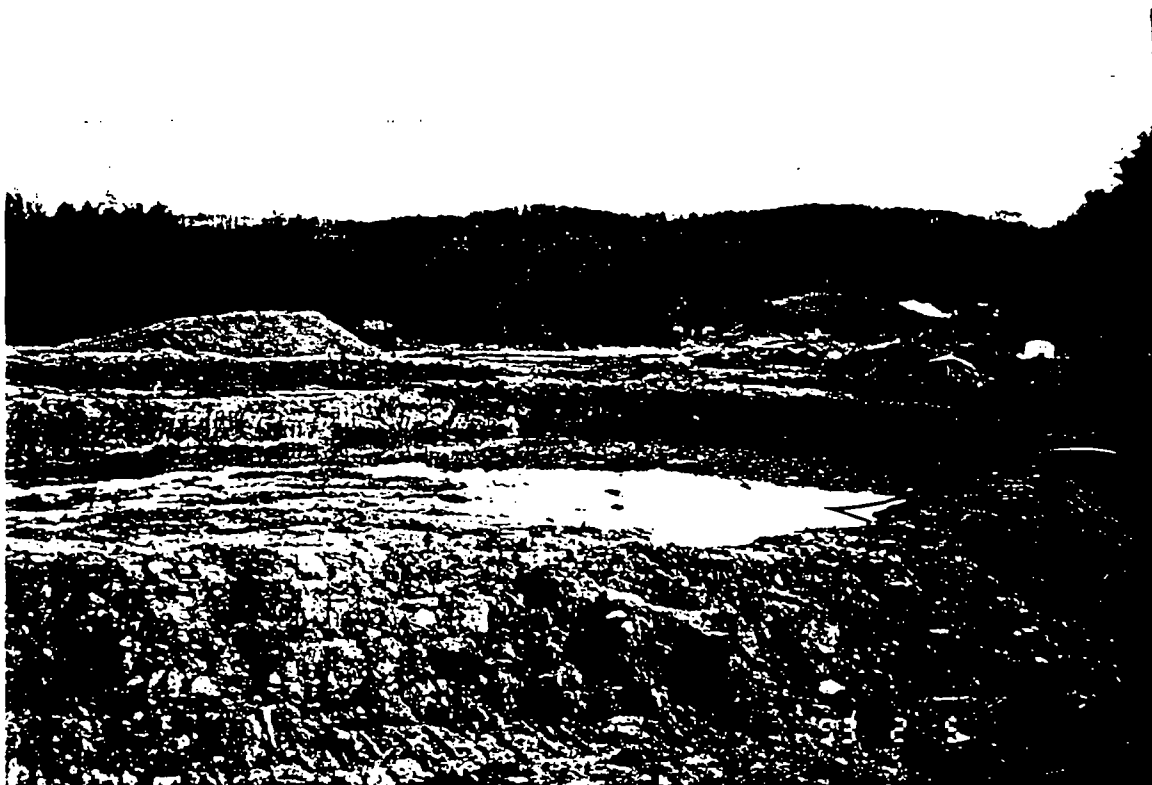
**Photograph No. 7**

Another observation worth noting is the collection pond capacity. The berms do not have the structural integrity to contain water if it is completely filled. This was apparent when leaking was observed when only 9000 gallons had been pumped to the pond. Although infiltration is the intended disposition, it will not occur at the rate in which treated water is discharged to this pond. As discussed with Consultant Tim Young, it may be necessary to run additional discharge line upgradient of this pond for discharge as it nears capacity. The addition line could be slotted pipe to disperse the water over a larger area enhancing the infiltration process.

**Description:** View of the collection pond receiving treated water.

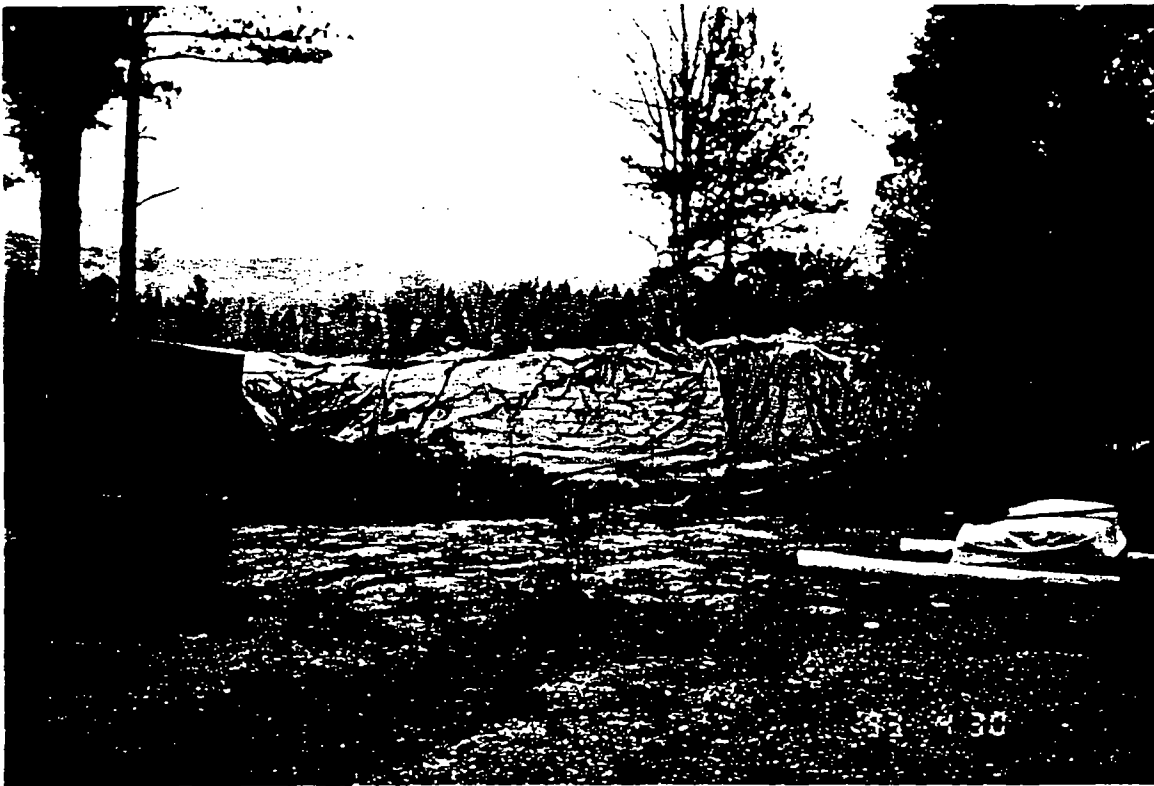
**Photograph No. 5**

**Description:** View of the inorganic contaminated soil pile recently recovered with visqueen.

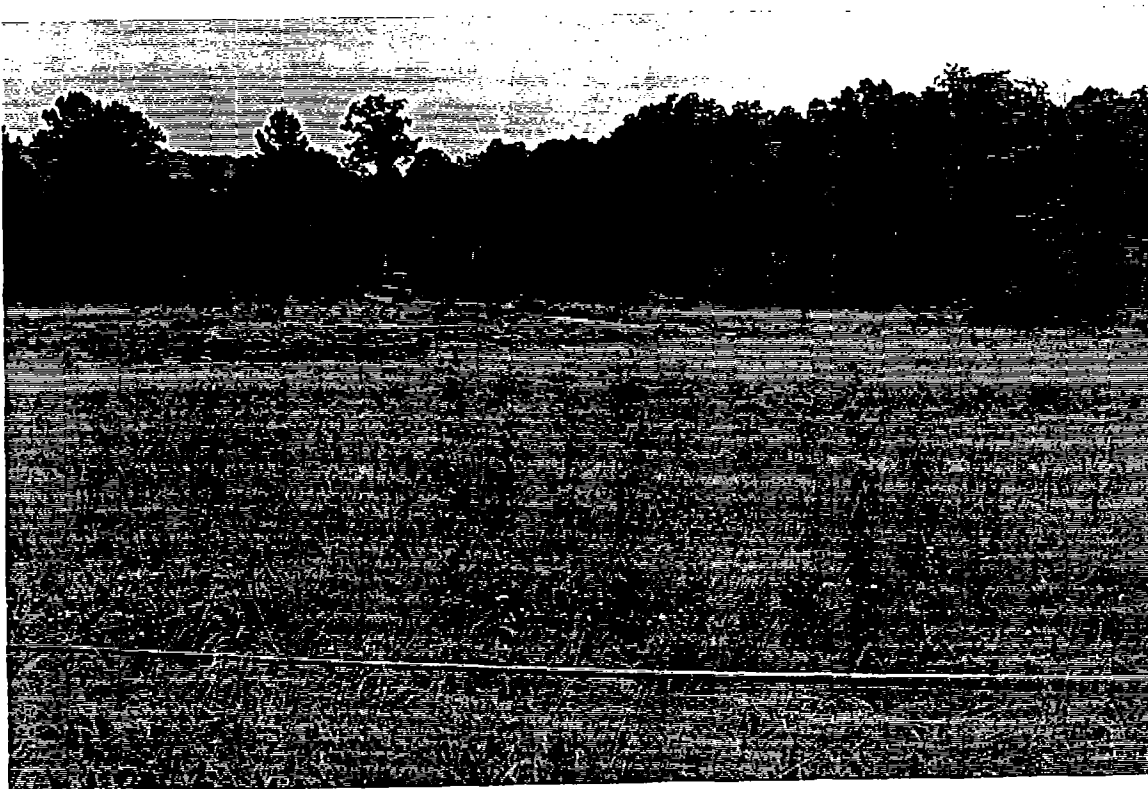
**Photograph No. 1**

**Description:** View of the central portion of the site prior to the start of remedial actions. PRP contractor, Shield Environmental Associates, Inc. (formerly Hatcher-Sayre, Inc.) cordoned off the areas to be excavated.

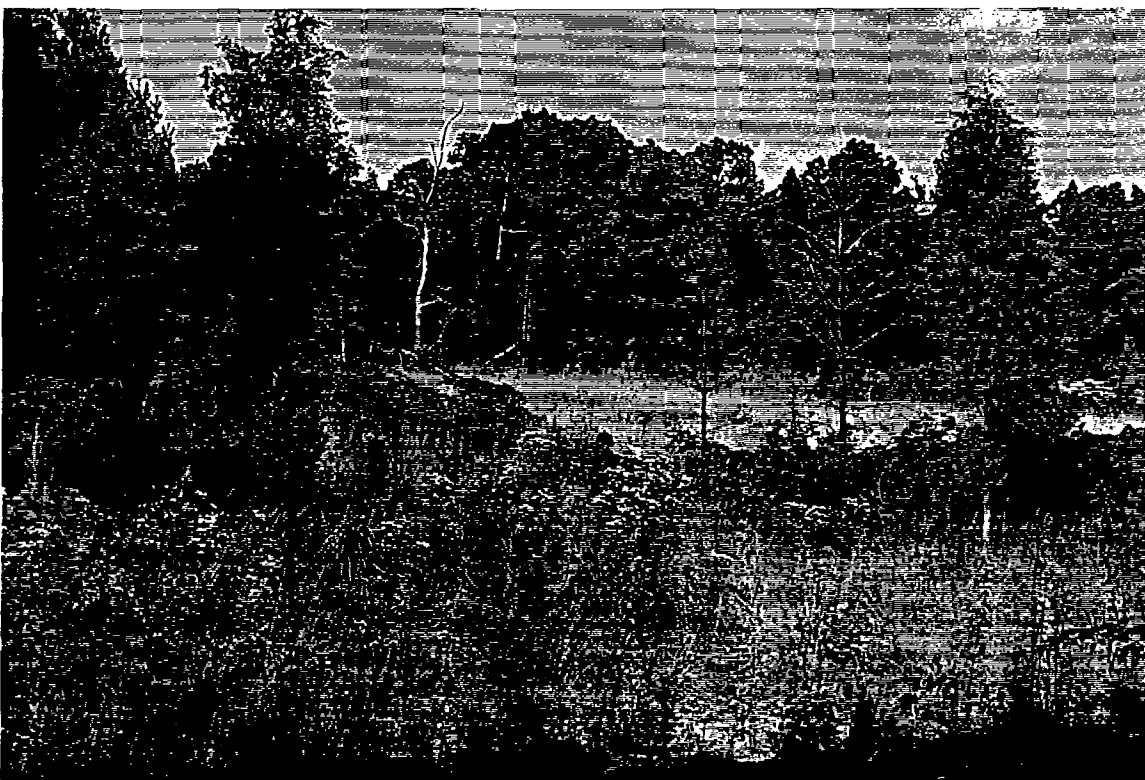
**Photograph No. 2**

**Description:** View of the north section of the site designated as Area 1.5D where soils contaminated with inorganics were excavated.

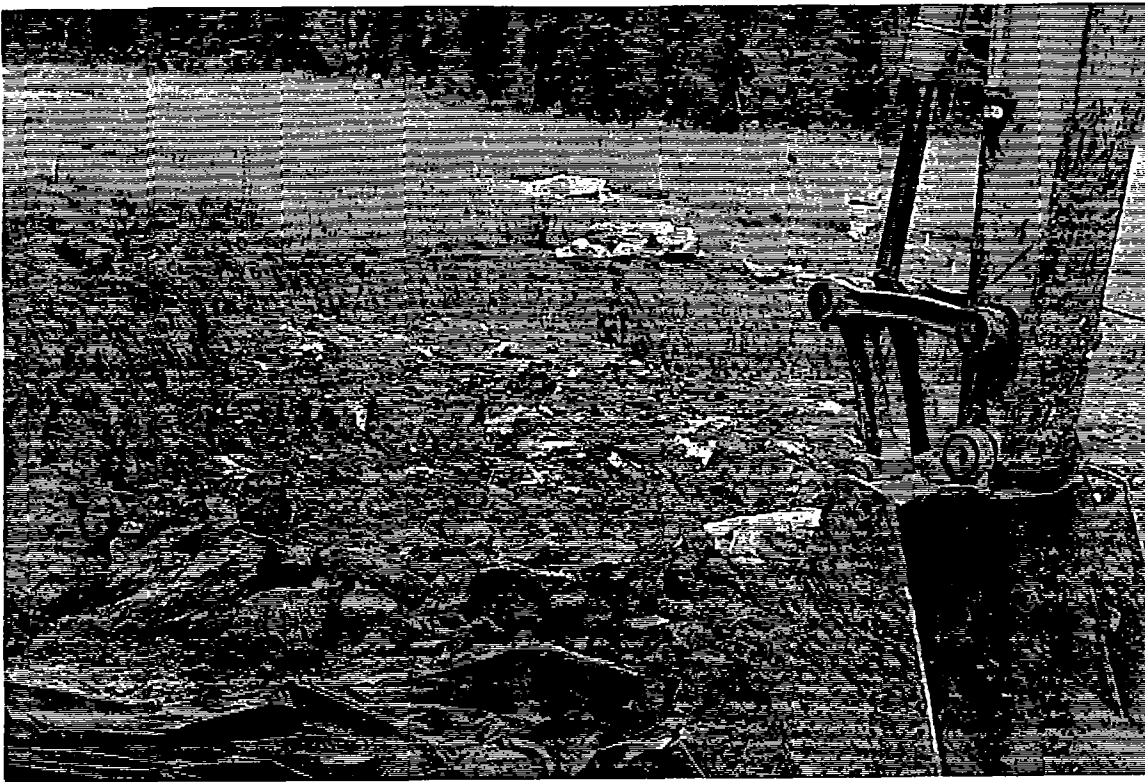
**Photograph No. 3**

**Description:** View of Area 7D being excavated to remove soils containing inorganic contamination.

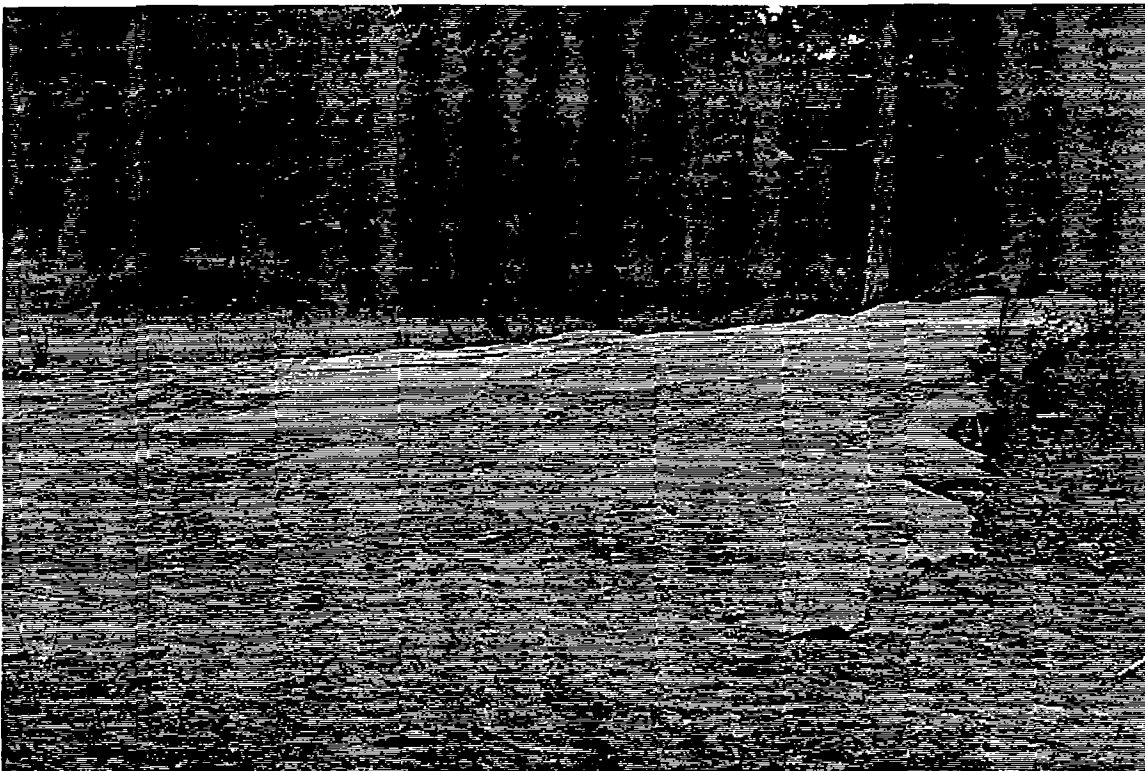
**Photograph No. 4**

**Description:** Staging area for inorganic contaminated soils prepared with plastic and overlain with 12 inches of sand.

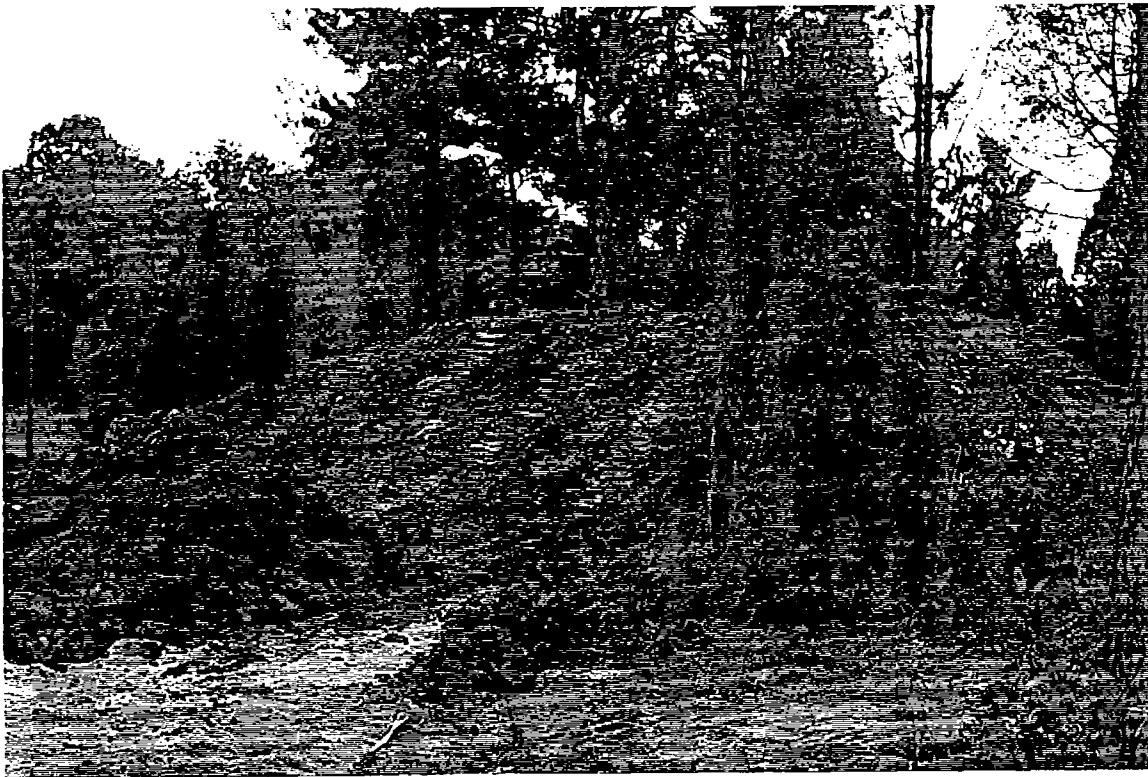
**Photograph No. 5**

**Description:** Inorganic contaminated soil being placed on staging pad until off-site disposal arrangements are completed.

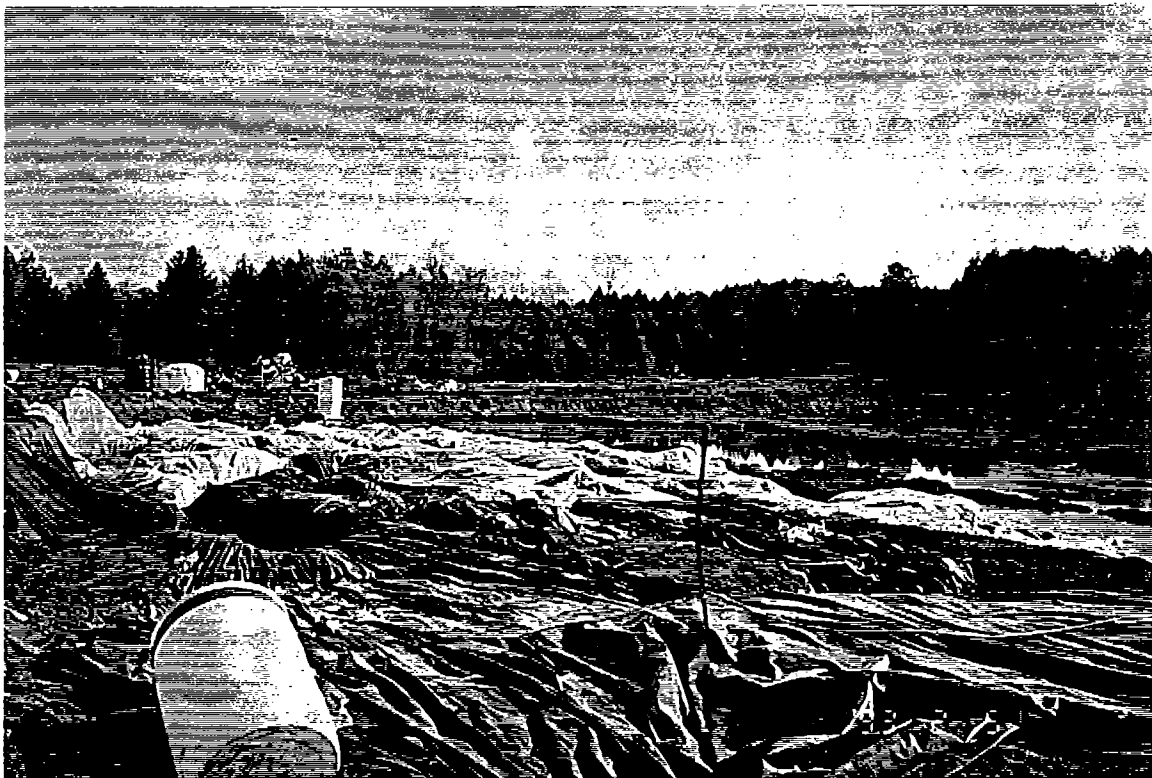
**Photograph No. 8**

**Description:** Water accumulated in the central excavation area being removed and treated.

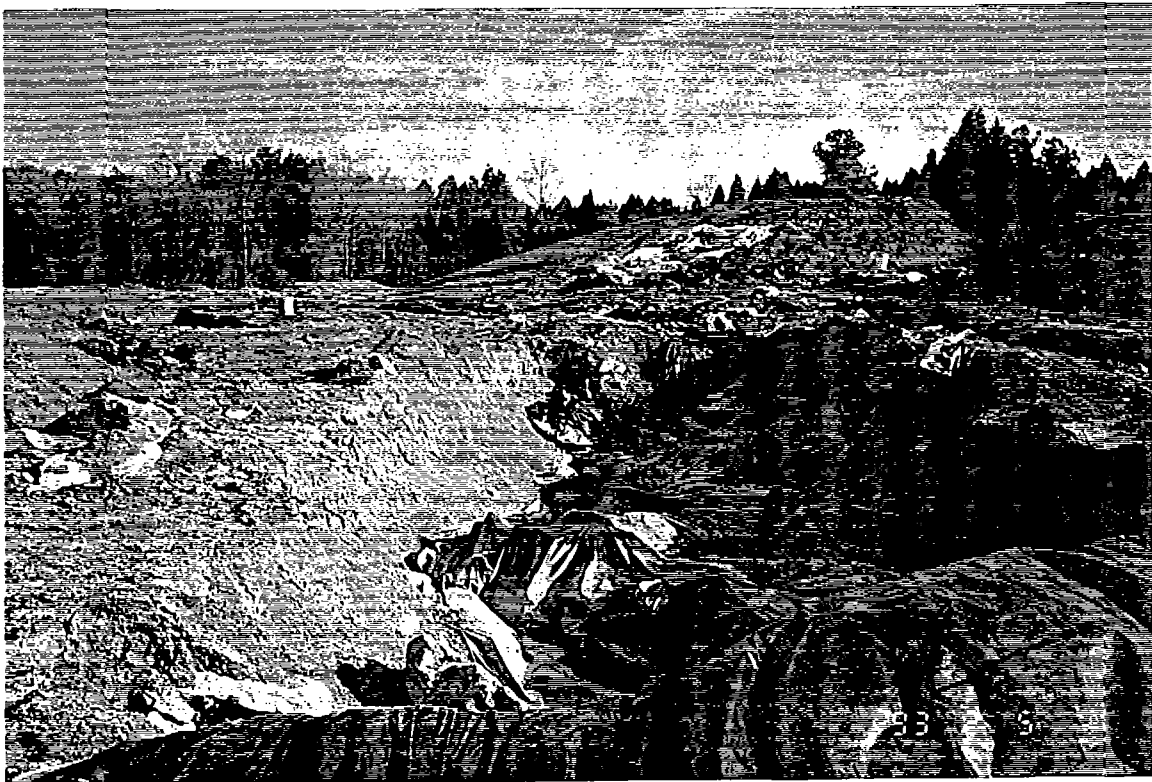
**Photograph No. 9**

**Description:** One of the two drum excavation and removal locations.

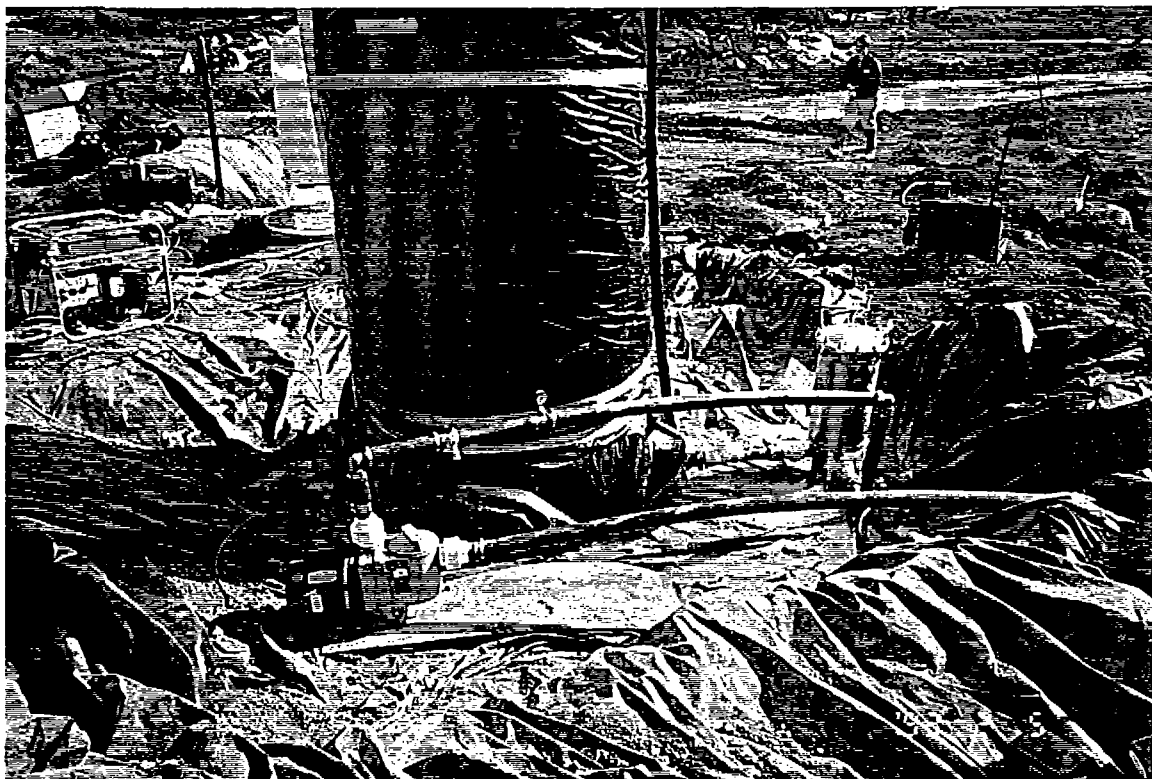
**Photograph No. 10**

**Description:** View of the granular activated carbon (GAC) unit, pump, and prefilter. The GAC unit was insulated and wrapped to prevent freezing.

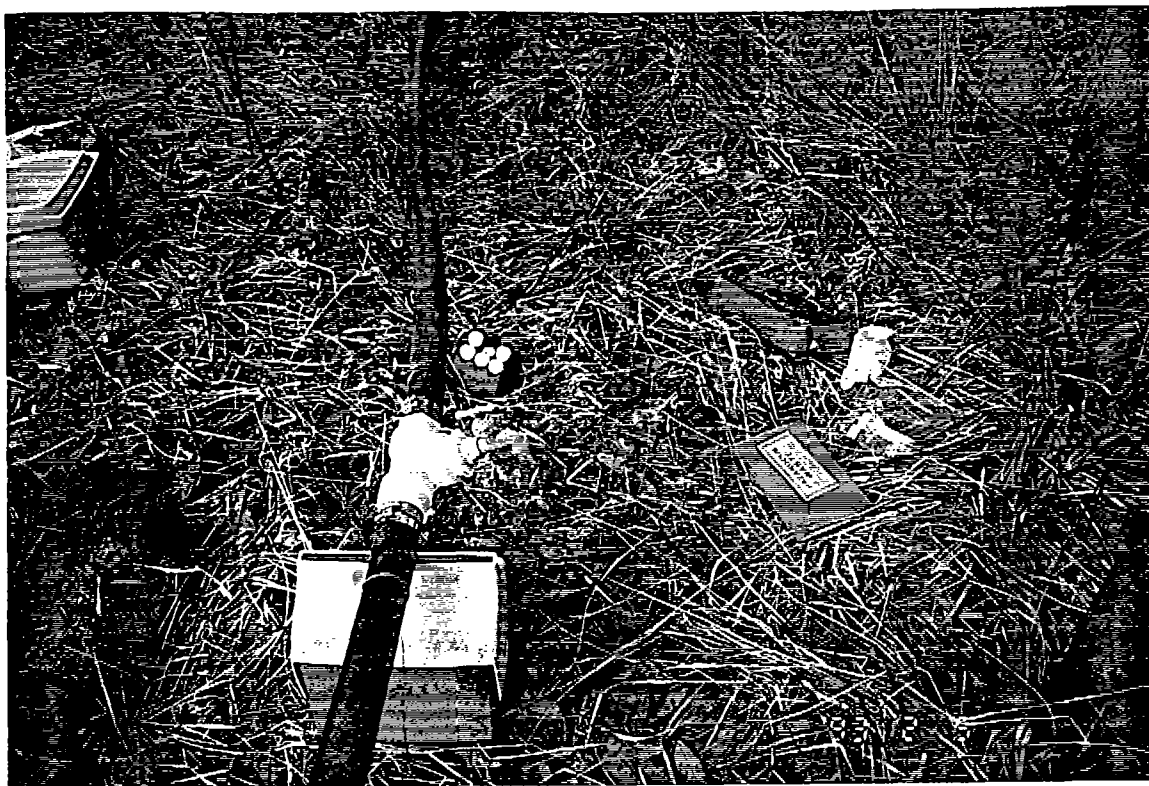
**Photograph No. 13**

**Description:** A sampling port was installed midway between the water treatment system and collection pond for sampling and analysis of effluent.

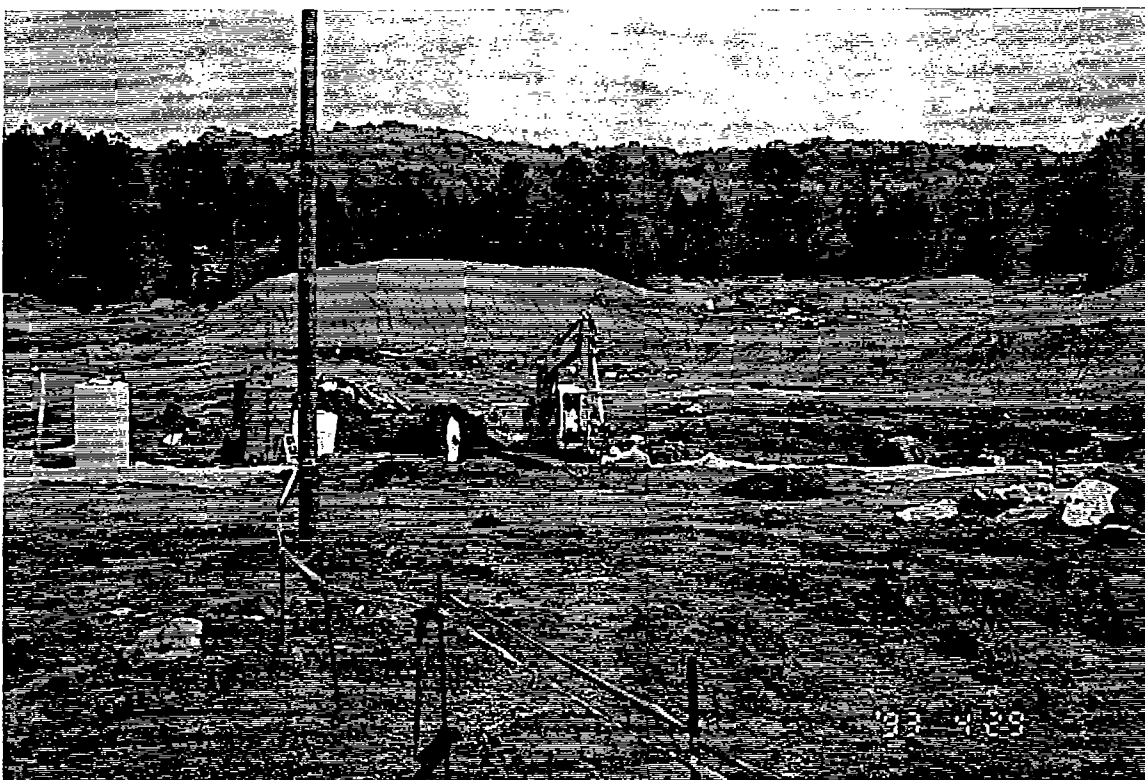
**Photograph No. 14**

**Description:** PRP Contractor, Shield Environmental, excavating to locate and remove organic liquids in the central excavation area. Large soil pile in background has been staged awaiting aeration treatment via roto-tilling.

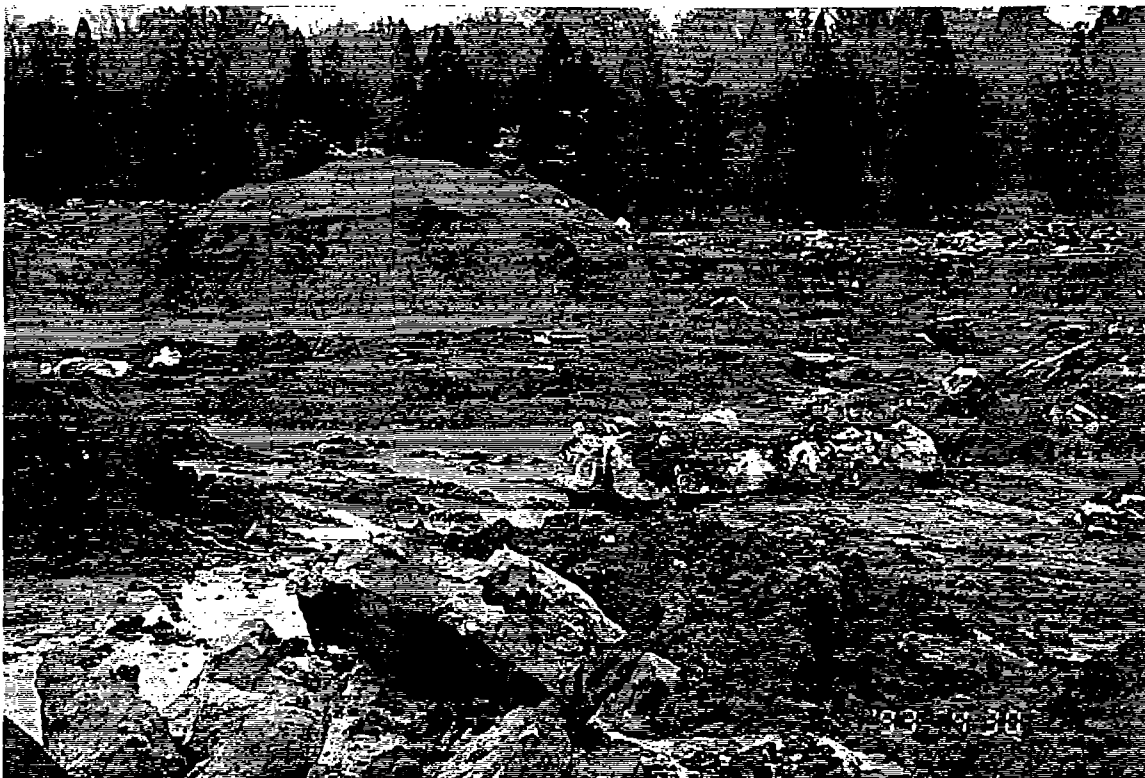
**Photograph No. 15**

**Description:** Sections of the upper bedrock layer removed to expose additional free organic liquids and contaminated soil.

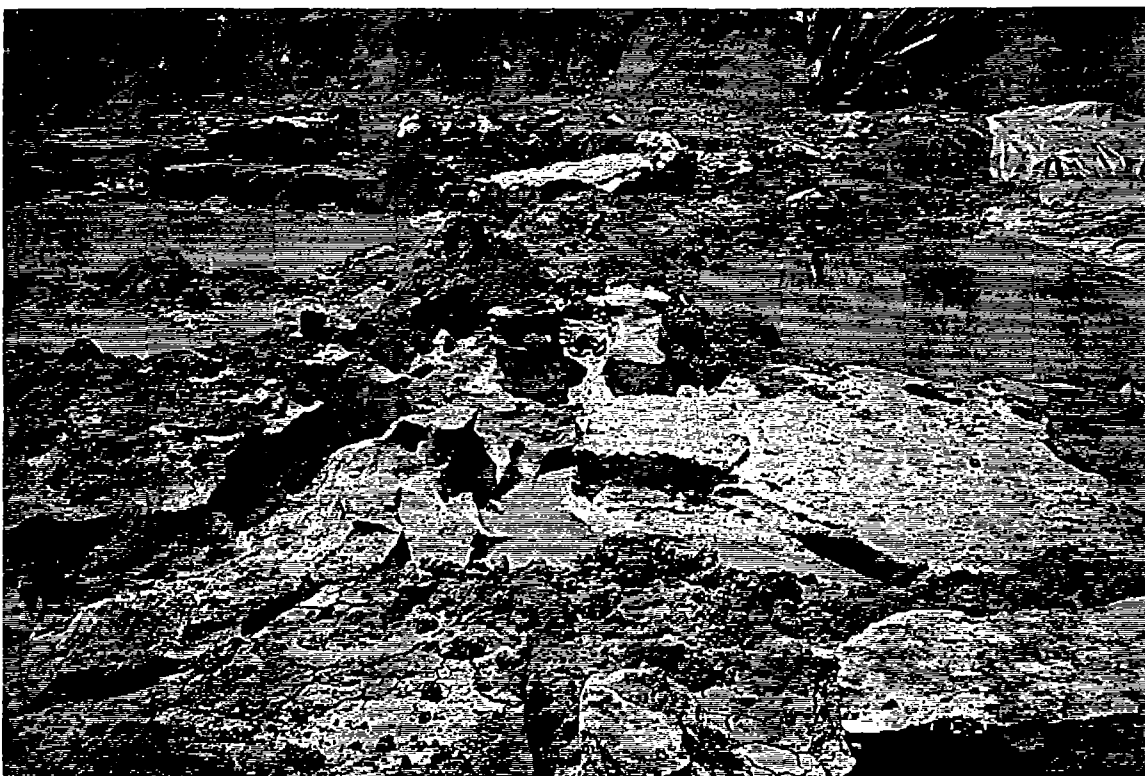
**Photograph No. 16**

**Description:** The underside of the bedrock layer which was turned over showing the solution features and cavities which contained free organic liquids and contaminated sediment

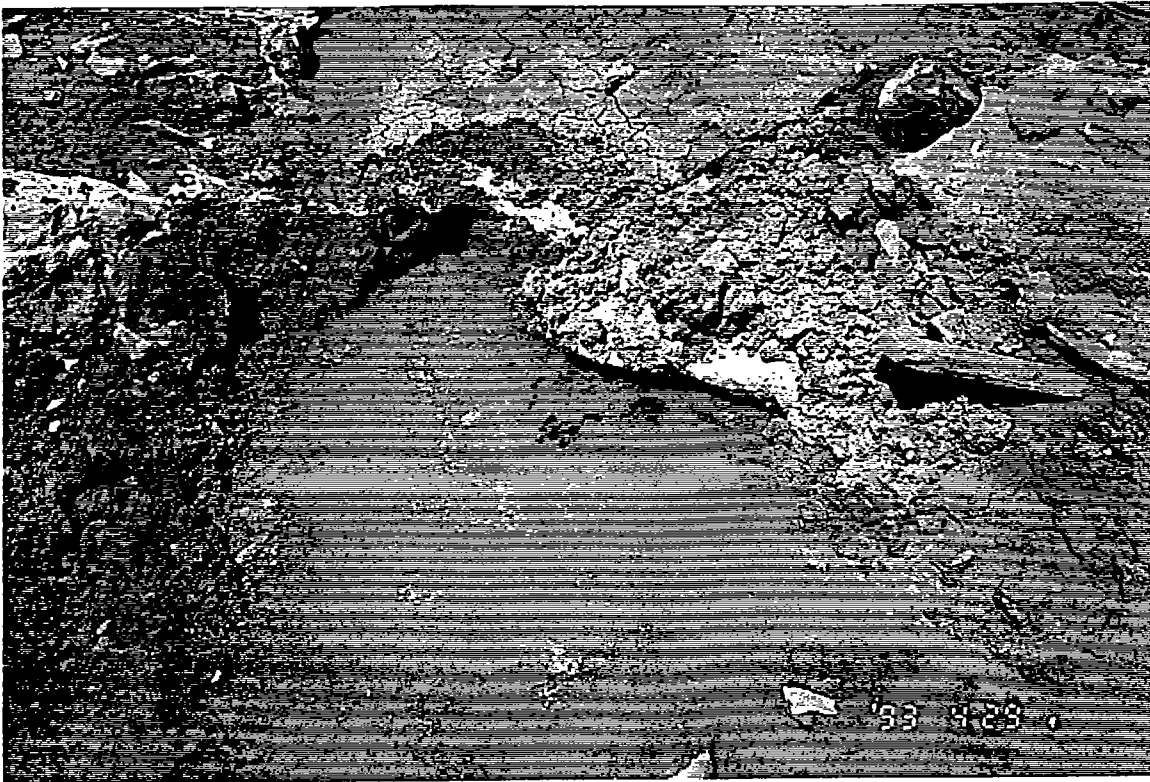
**Photograph No. 17**

**Description:** Free liquids exposed when upper layer of bedrock was removed.

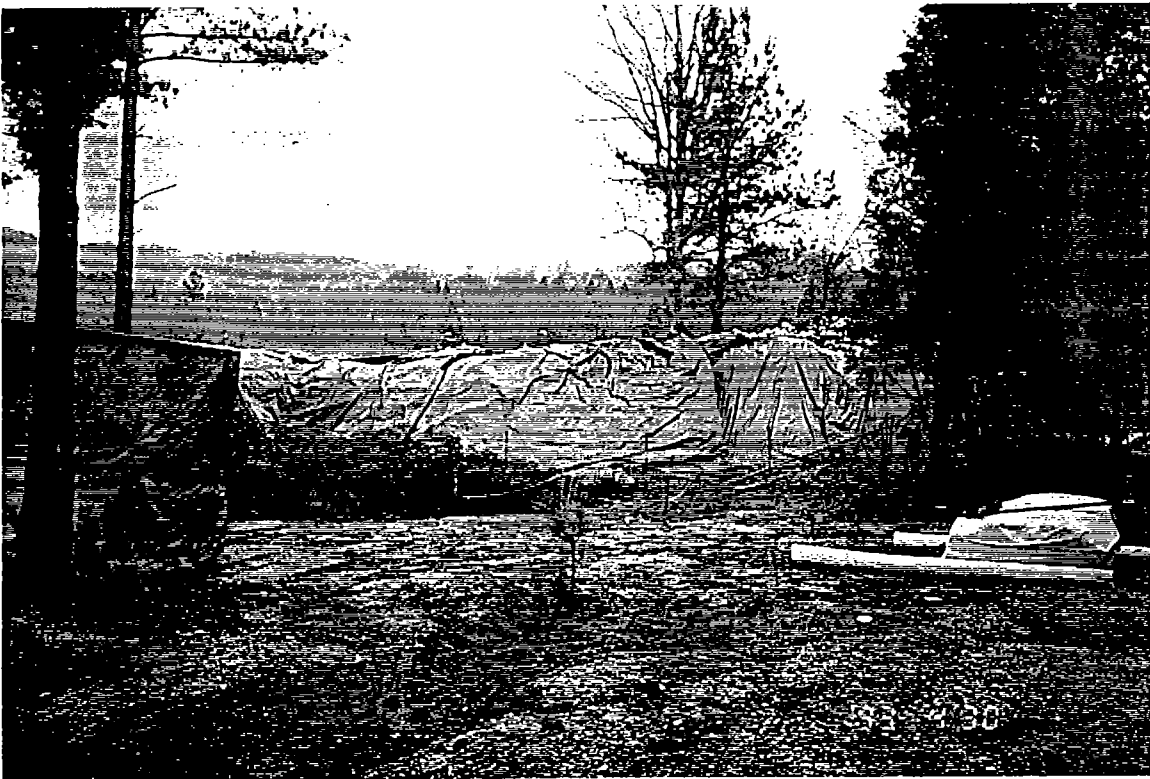
**Photograph No. 18**

**Description:** View of the inorganic contaminated soil pile recently re-covered with visqueen awaiting final disposal.

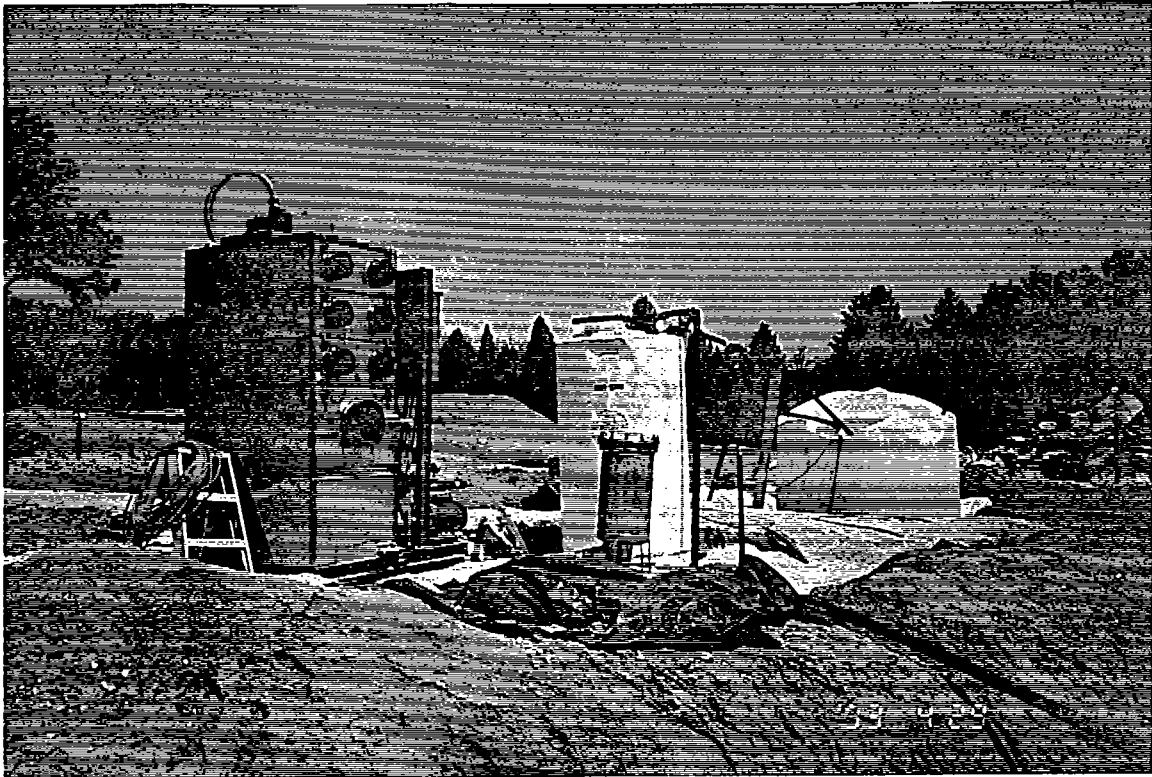
**Photograph No. 19**

**Description:** View of water treatment system upgraded to include a low profile air stripper (left) for removal of organic contaminants. GAC unit in center discharging to holding tank.

The high concentration of organics in the liquid caused the GAC units to be spent quickly; therefore, a low profile air stripper was installed ahead of the GAC unit to remove organics and increase the life of the carbon.

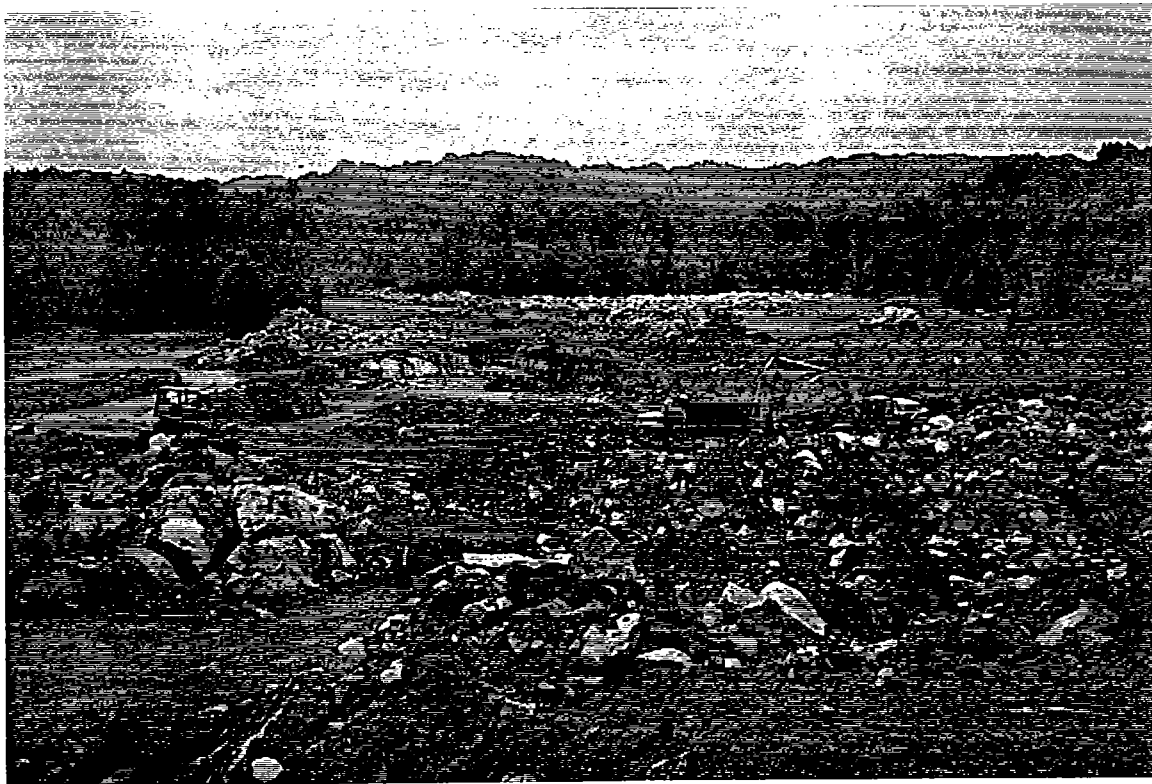
**Photograph No. 20**

**Description:** Removal of upper limestone bedrock to expose and remove additional organic liquids and stained soils.

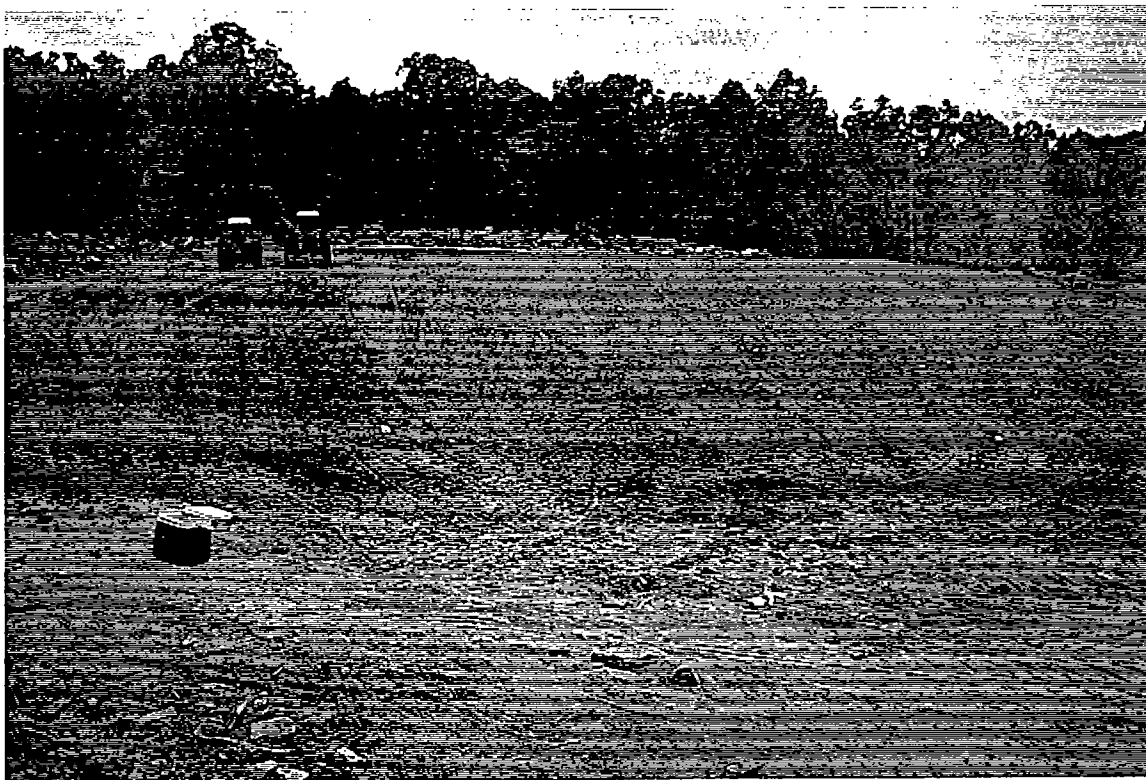
**Photograph No. 21**

**Description:** Aeration of organic contaminated soils using roto-tilling method powered by farm tractors.
